BEFORE ALL HAIL BREAKS LOOSE!

2018 MHEC MPP LOSS CONTROL WORKSHOP

Jared Stolin
Property Risk Consultant, Marsh Risk Consulting

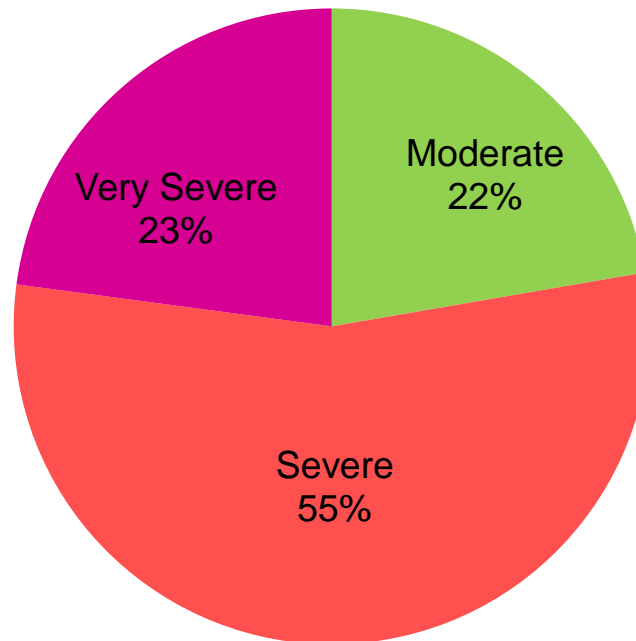
Hail Ratings by Location (FMDS 1-34)

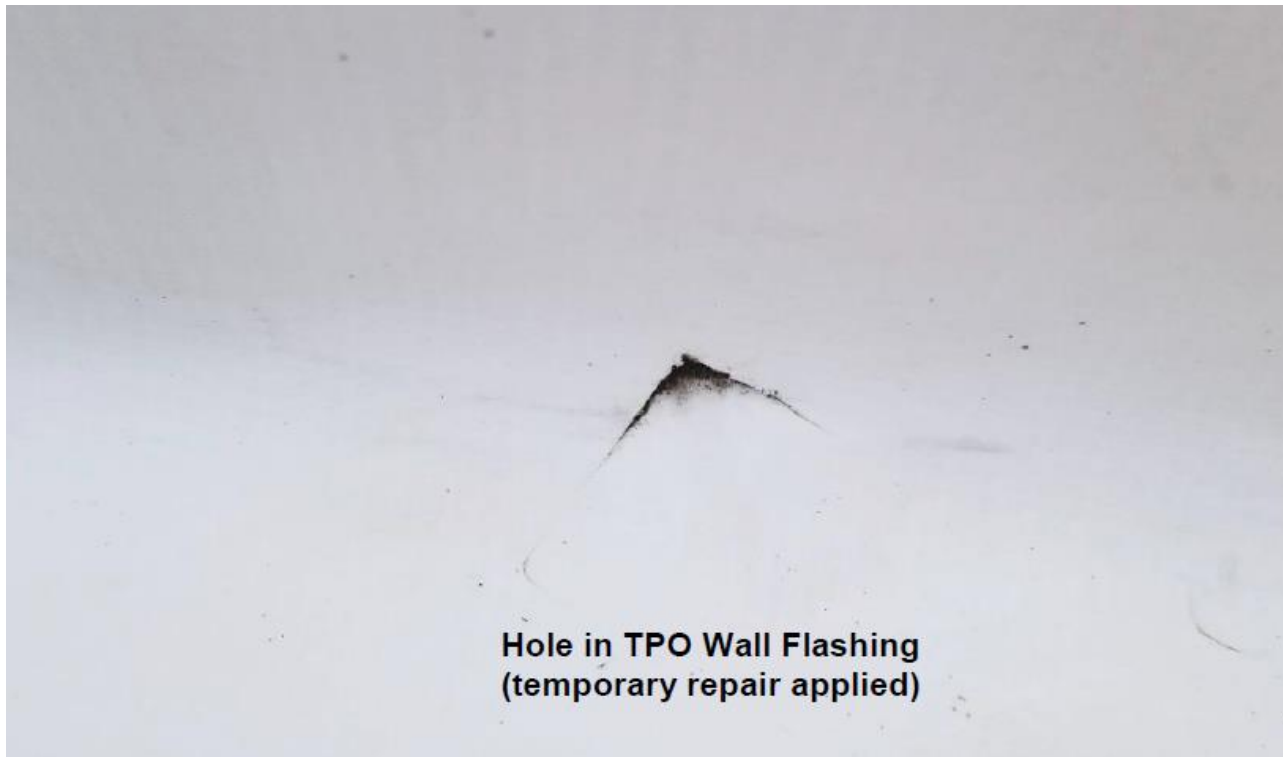
**Hole in TPO Wall Flashing
(temporary repair applied)**

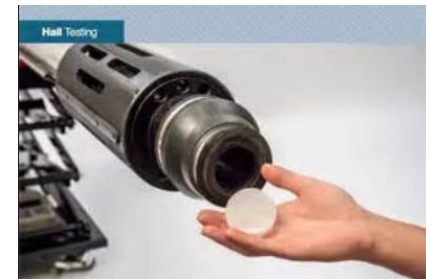
ANSI FM 4473

- Ice balls are used in this test method to simulate hailstones.
- The test specimen shall show no evidence of visible cracking or breakage or any damage such as punctures, fractures, disengagement of lap elements or exposure of materials not so intended.

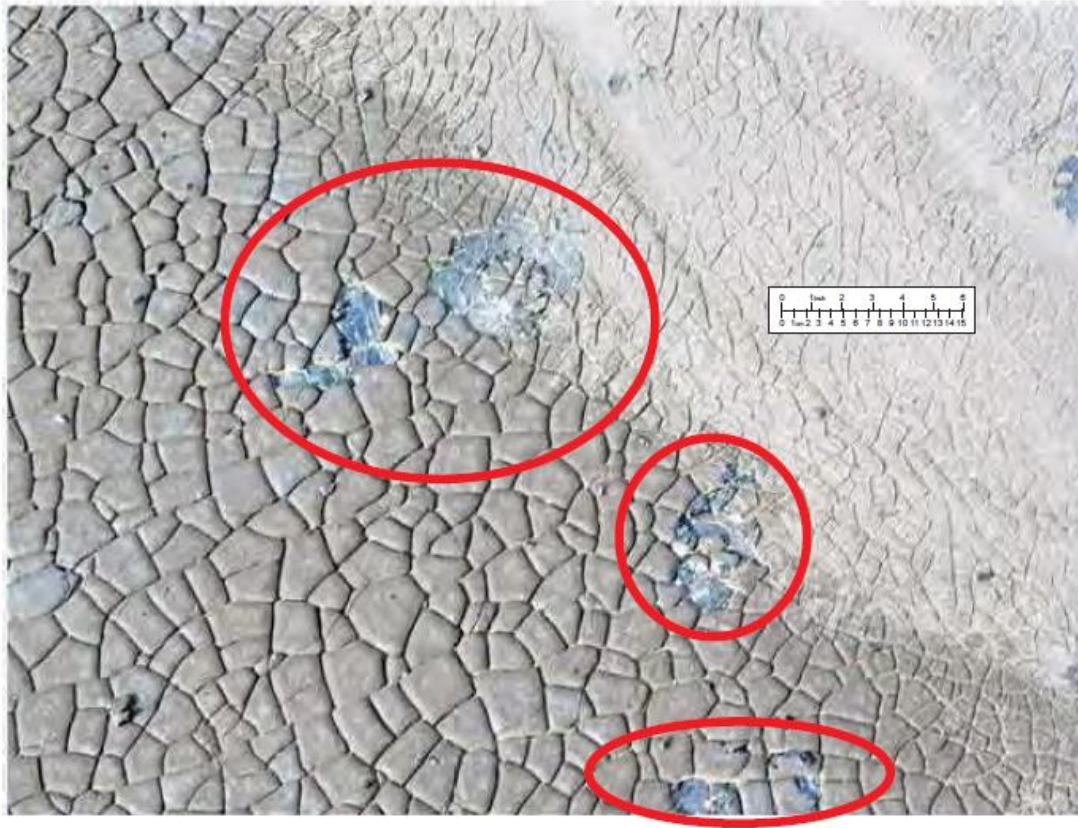
Fig. 5. Hail damage to severely "alligatored" roof (built-up roof)

- Original surface coating, such as granules or gravel missing
- blisters, deteriorating felts (scrim is showing) and alligator surfaces

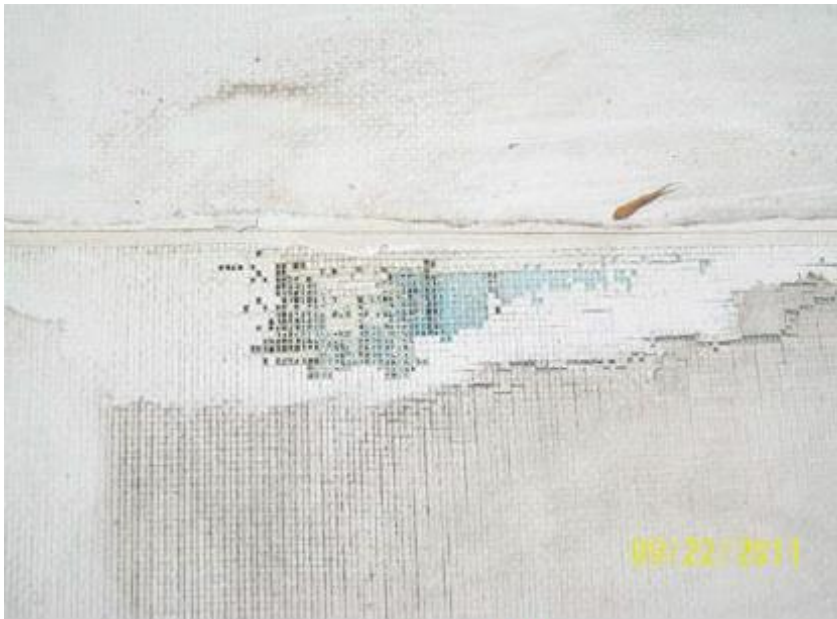
Figure 1 – Severe deterioration of TPO membrane with embrittled/loss of top coating and exposed scrim.

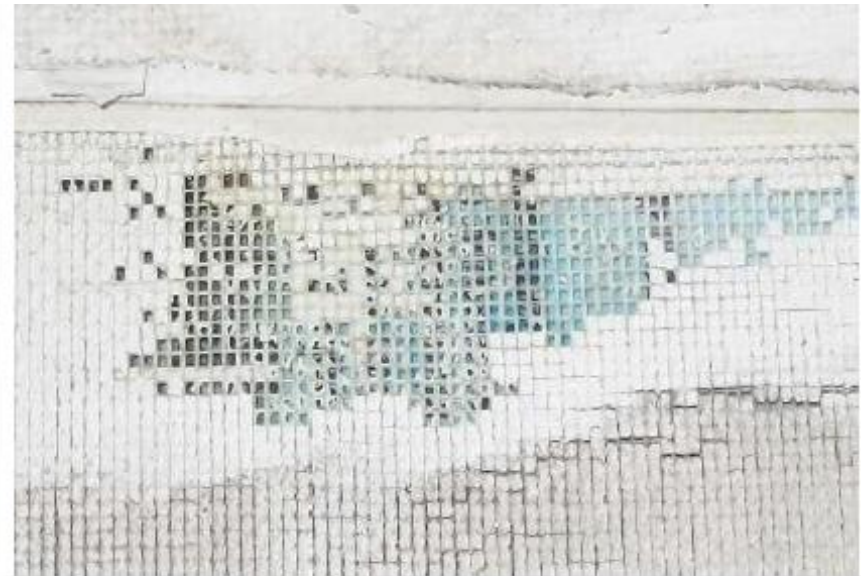
Figure 2 – Close-up view of deteriorated TPO membrane with embrittled/loss of top coating and exposed scrim.

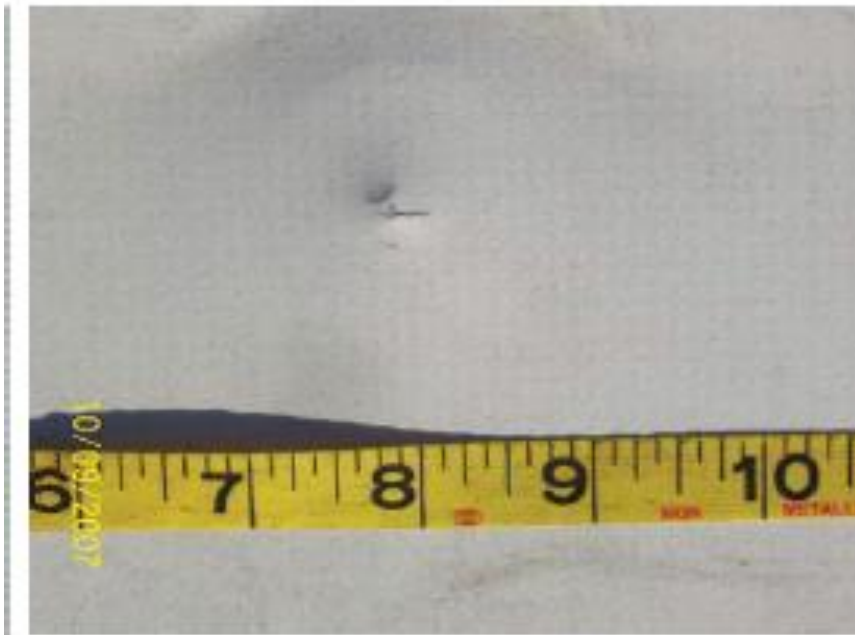
Figure 14 – Cracking in top surface of TPO membrane at fastener head protruding up on membrane.

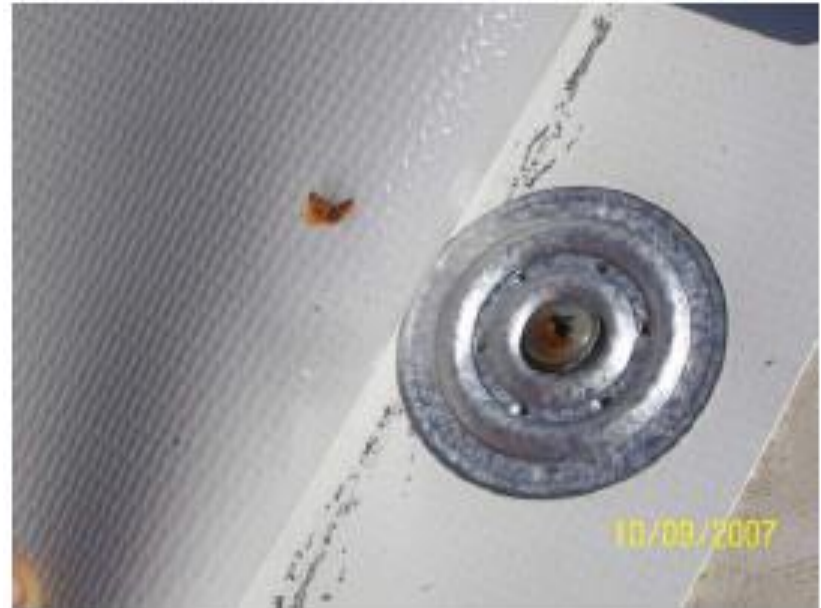
Figure 16 – View of underside of membrane at crack revealing corrosion on fastener head.

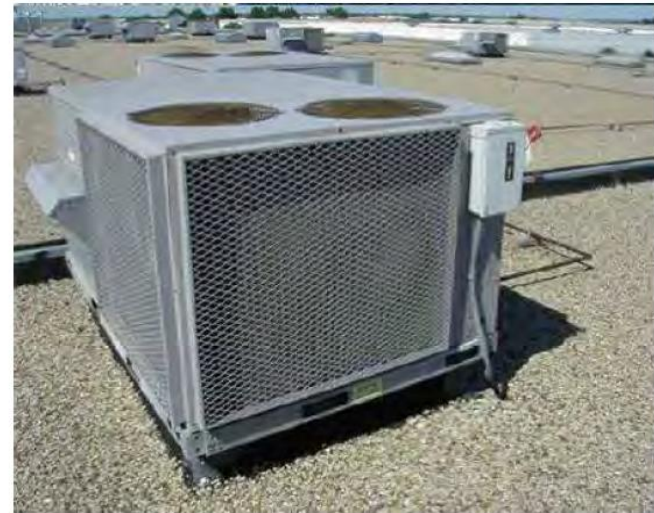
Fig. 4. HVAC unit with hail guard over cooling fins at same location as hail damaged unit in Figure 3

- Provide hail guards or steel wire mesh
- Min No. 11 gauge diameter steel wire mesh with maximum mesh opening size of 1.0 in. and supported on a steel framework
